# WARTIME REPORT

January 1946 as  
Advance Restricted Report E5L18a

SINGLE-CYLINDER ENGINE TESTS OF POROUS CHROME-PLATED  
CYLINDER BARRELS WITH SPECIAL BORE COATINGS  
FOR RADIAL AIR-COOLED ENGINES

By Robert L. Johnson and Roy I. Anderson

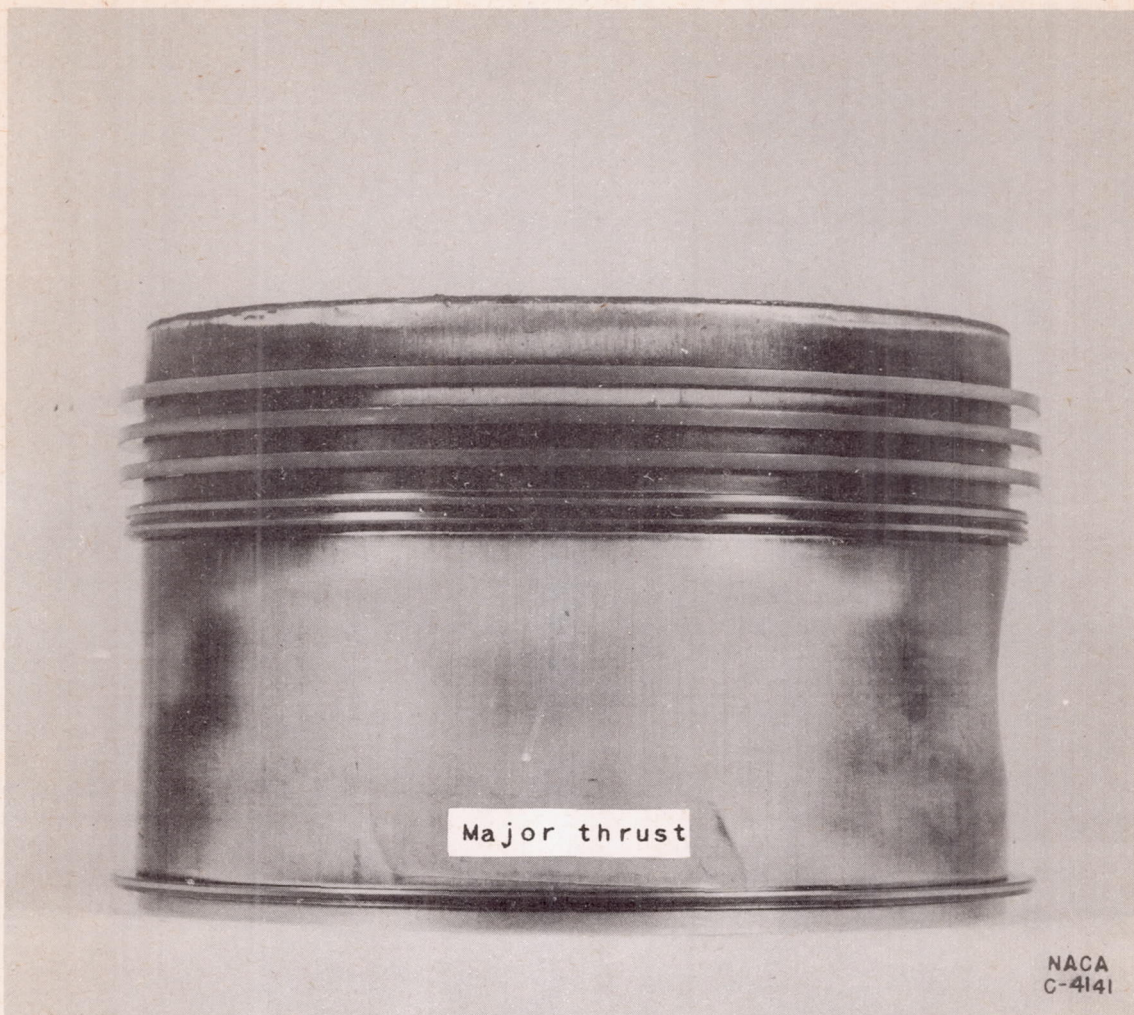
Figure 10. - Major-thrust face of piston run in a choke-bore porous chrome-plated cylinder barrel with a silver over-plate. Condition after test 8.

areas in which the silver did not completely adhere. The irregularity of the appearance of the bore shown in figure 9 does not indicate harmful operating characteristics. This observation is substantiated by figure 10, which shows the piston assembly run in test 8; the assembly is considered to be in very good condition.
